Ir. R.R. van der Zeelaan 10
8191 HZ Wapenveld, The Netherlands

INSTALLATION DETAILS

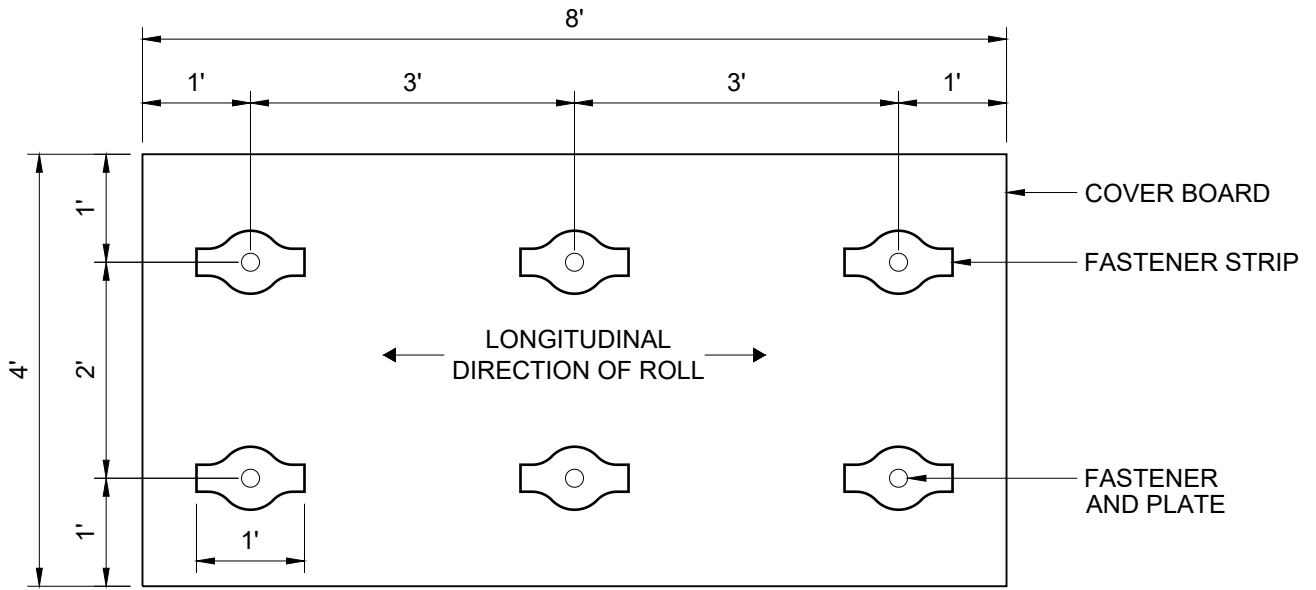
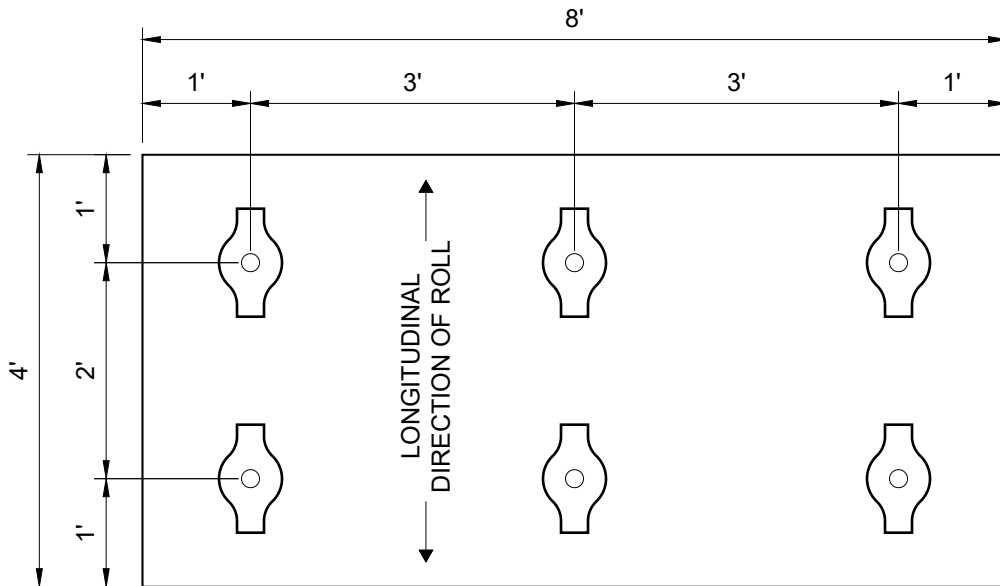
LR001

[6 FASTENERS PER BOARD]
TYPICAL FASTENER PATTERN DETAIL

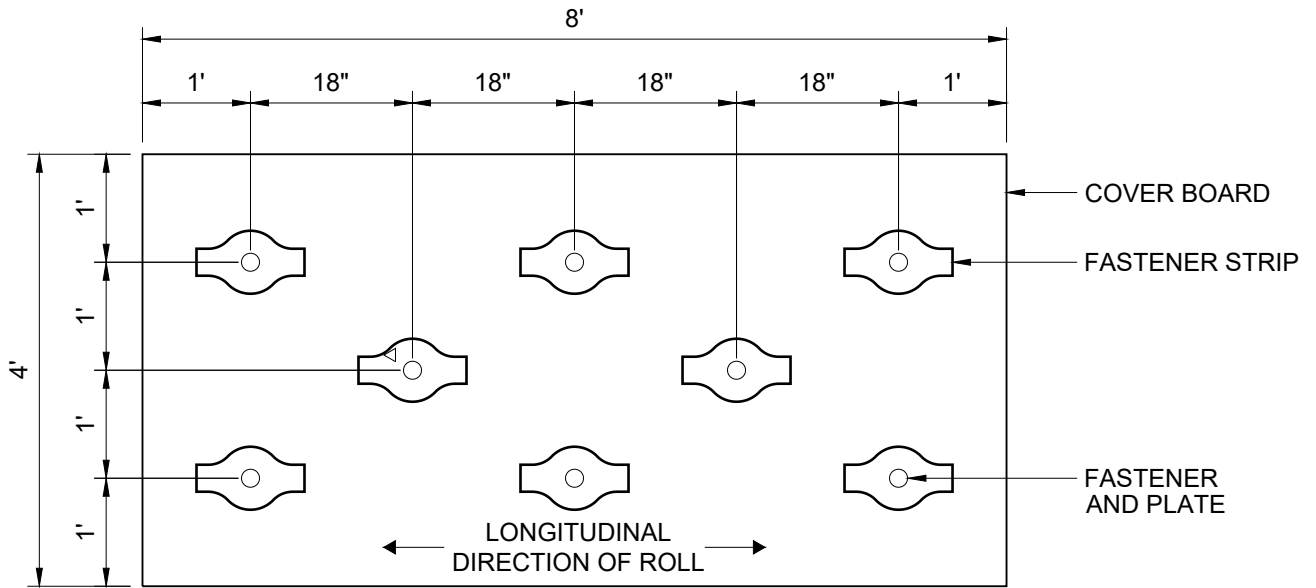
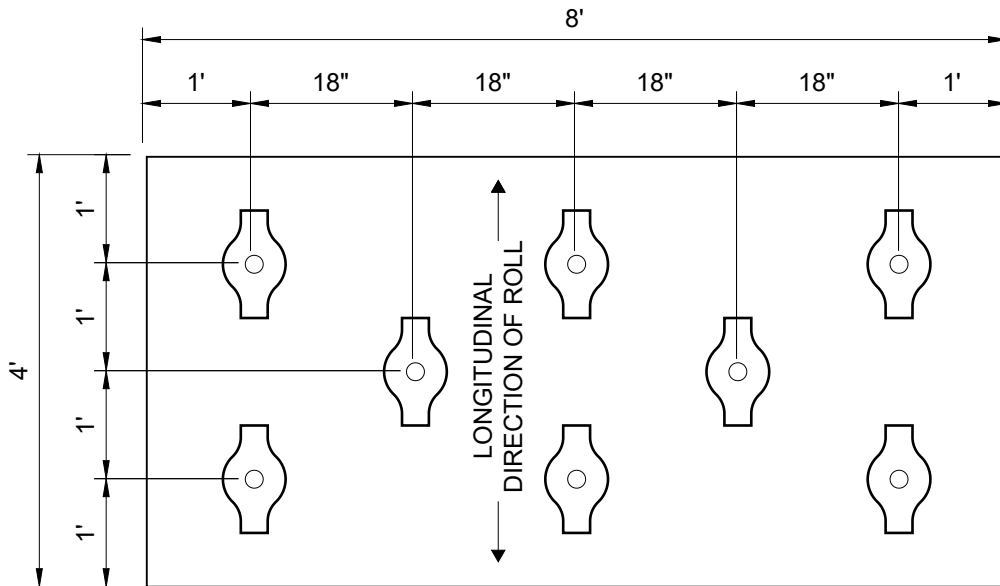
LR002

[8 FASTENERS PER BOARD]
TYPICAL FASTENER PATTERN DETAIL

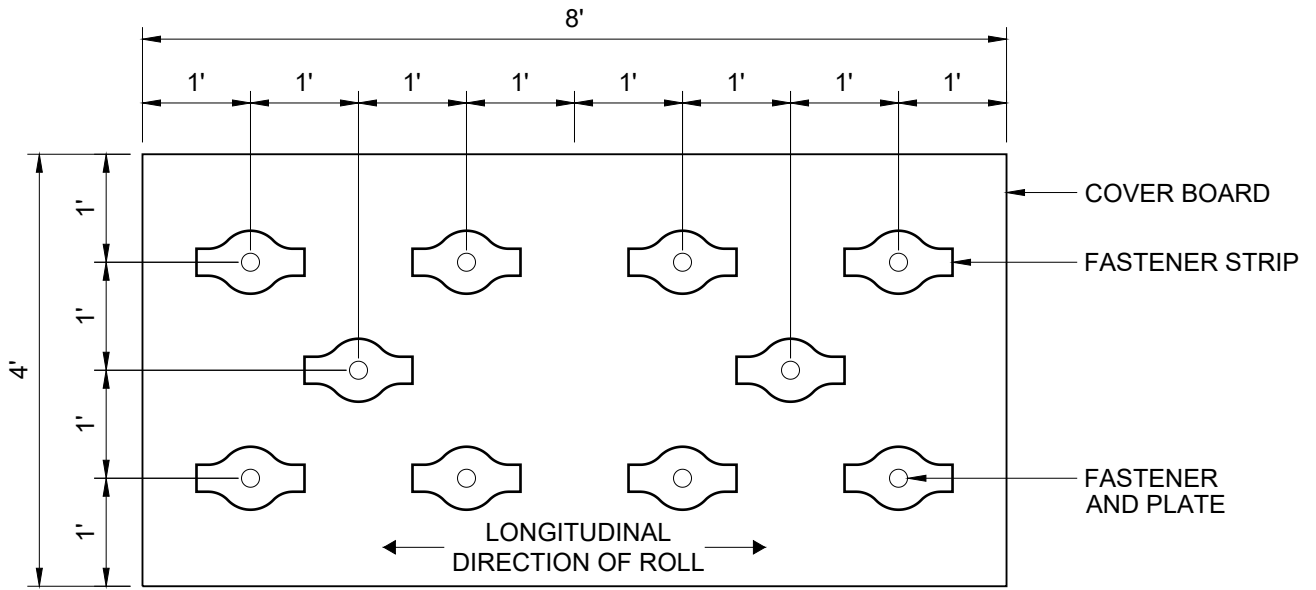
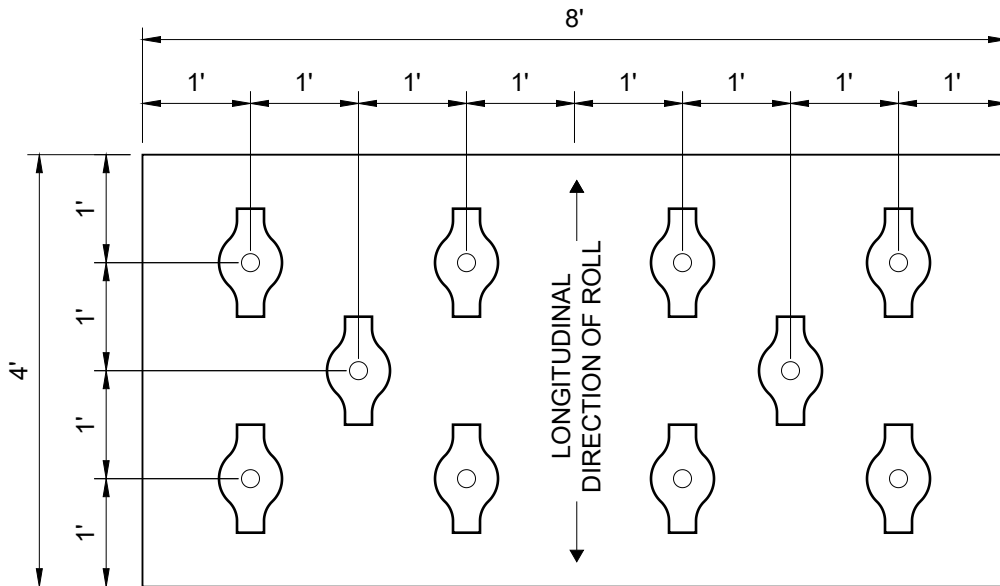
LR003

[10 FASTENERS PER BOARD]
TYPICAL FASTENER PATTERN DETAIL

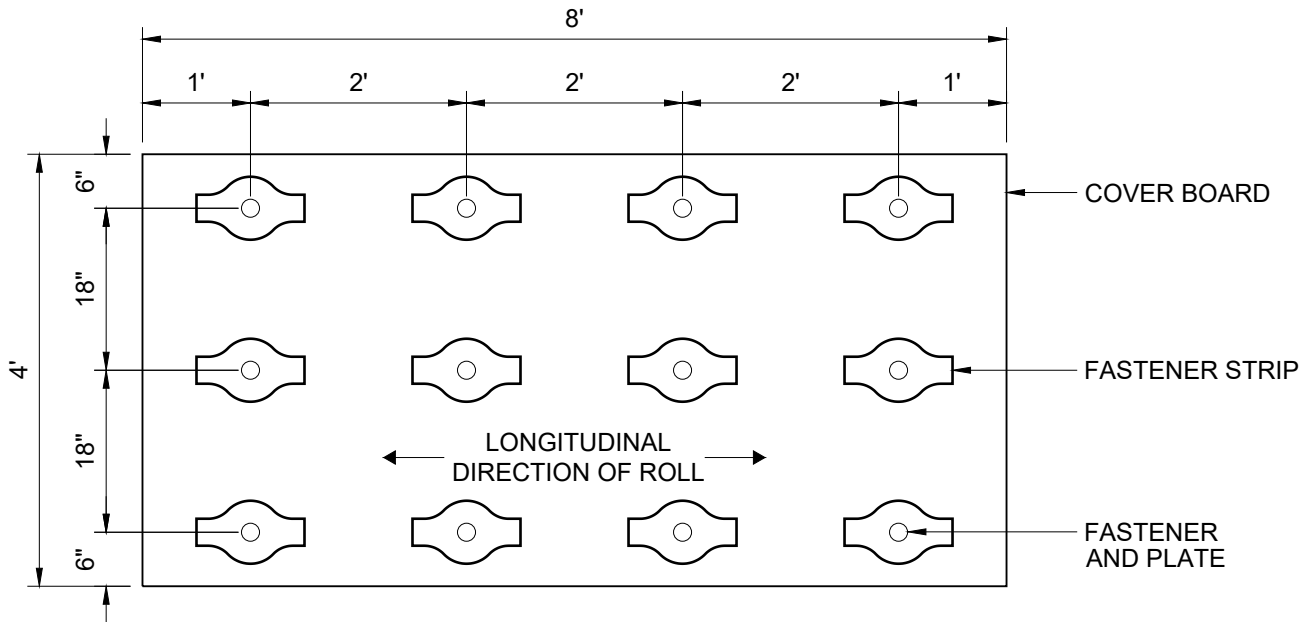
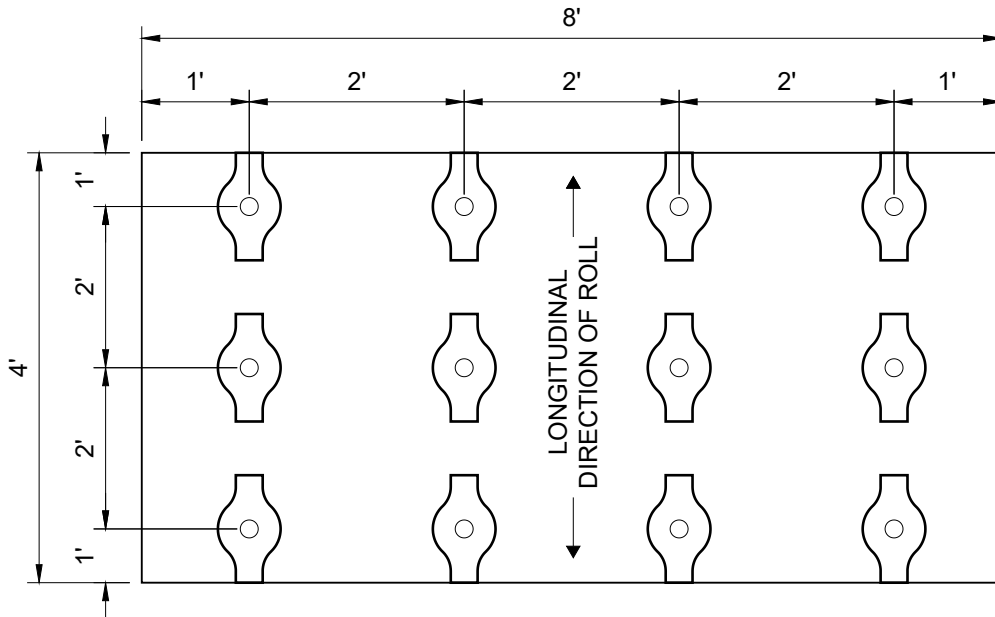
LR004

[12 FASTENERS PER BOARD]
TYPICAL FASTENER PATTERN DETAIL

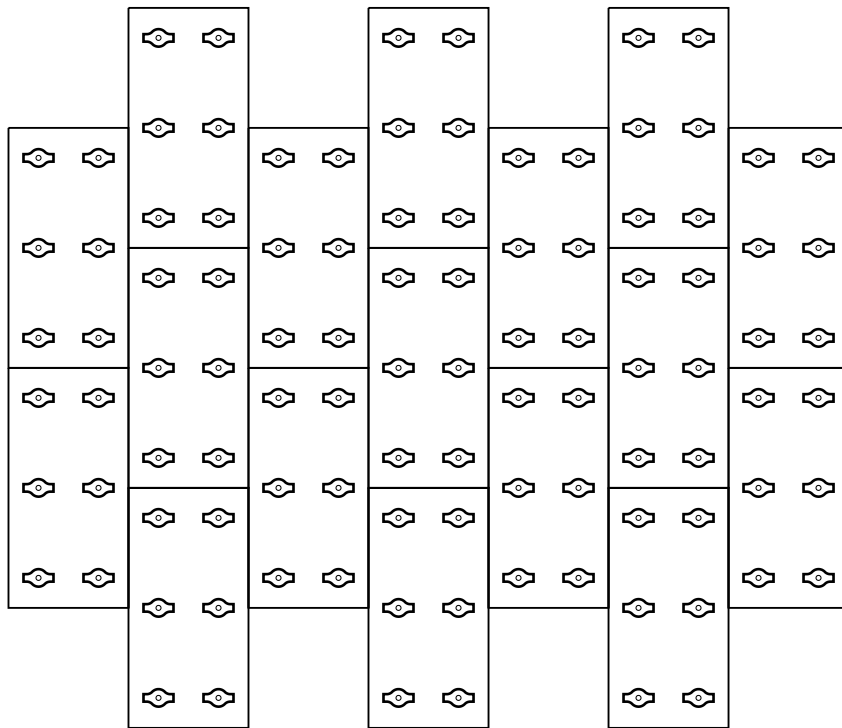
LR005

← LONGITUDINAL DIRECTION OF ROLL →

[ZONE 1 - FIELD]
TYPICAL FASTENER LAYOUT FOR FM 1-90 OR LESS

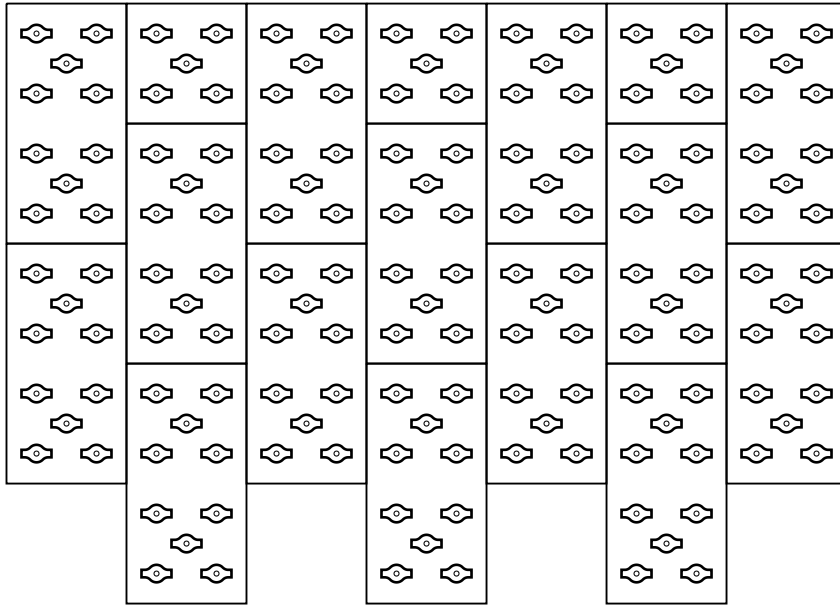
LR006

← LONGITUDINAL DIRECTION OF ROLL →

[ZONE 2 - PERIMETER]
TYPICAL FASTENER LAYOUT FOR FM 1-90 OR LESS

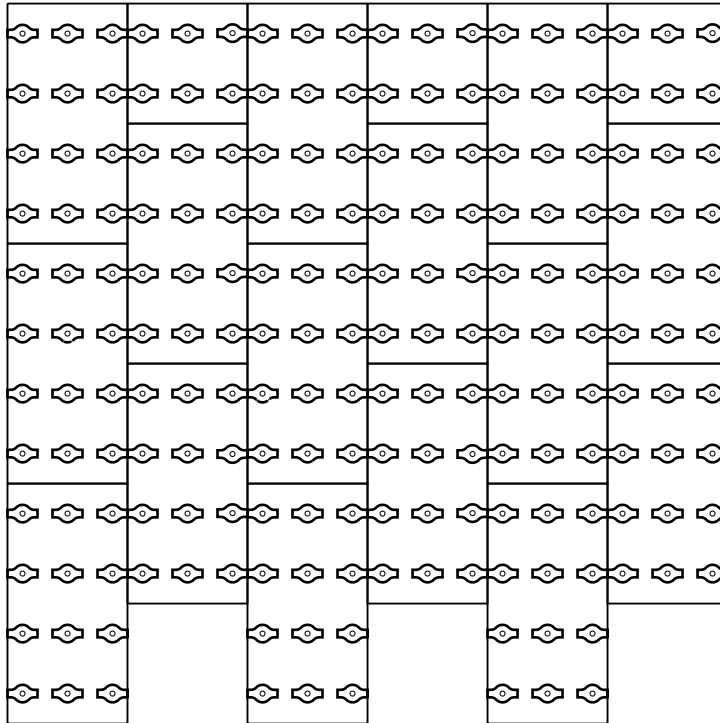
LR007

← LONGITUDINAL DIRECTION OF ROLL →

[ZONE 3 - CORNER]
TYPICAL FASTENER LAYOUT FOR FM 1-90 OR LESS

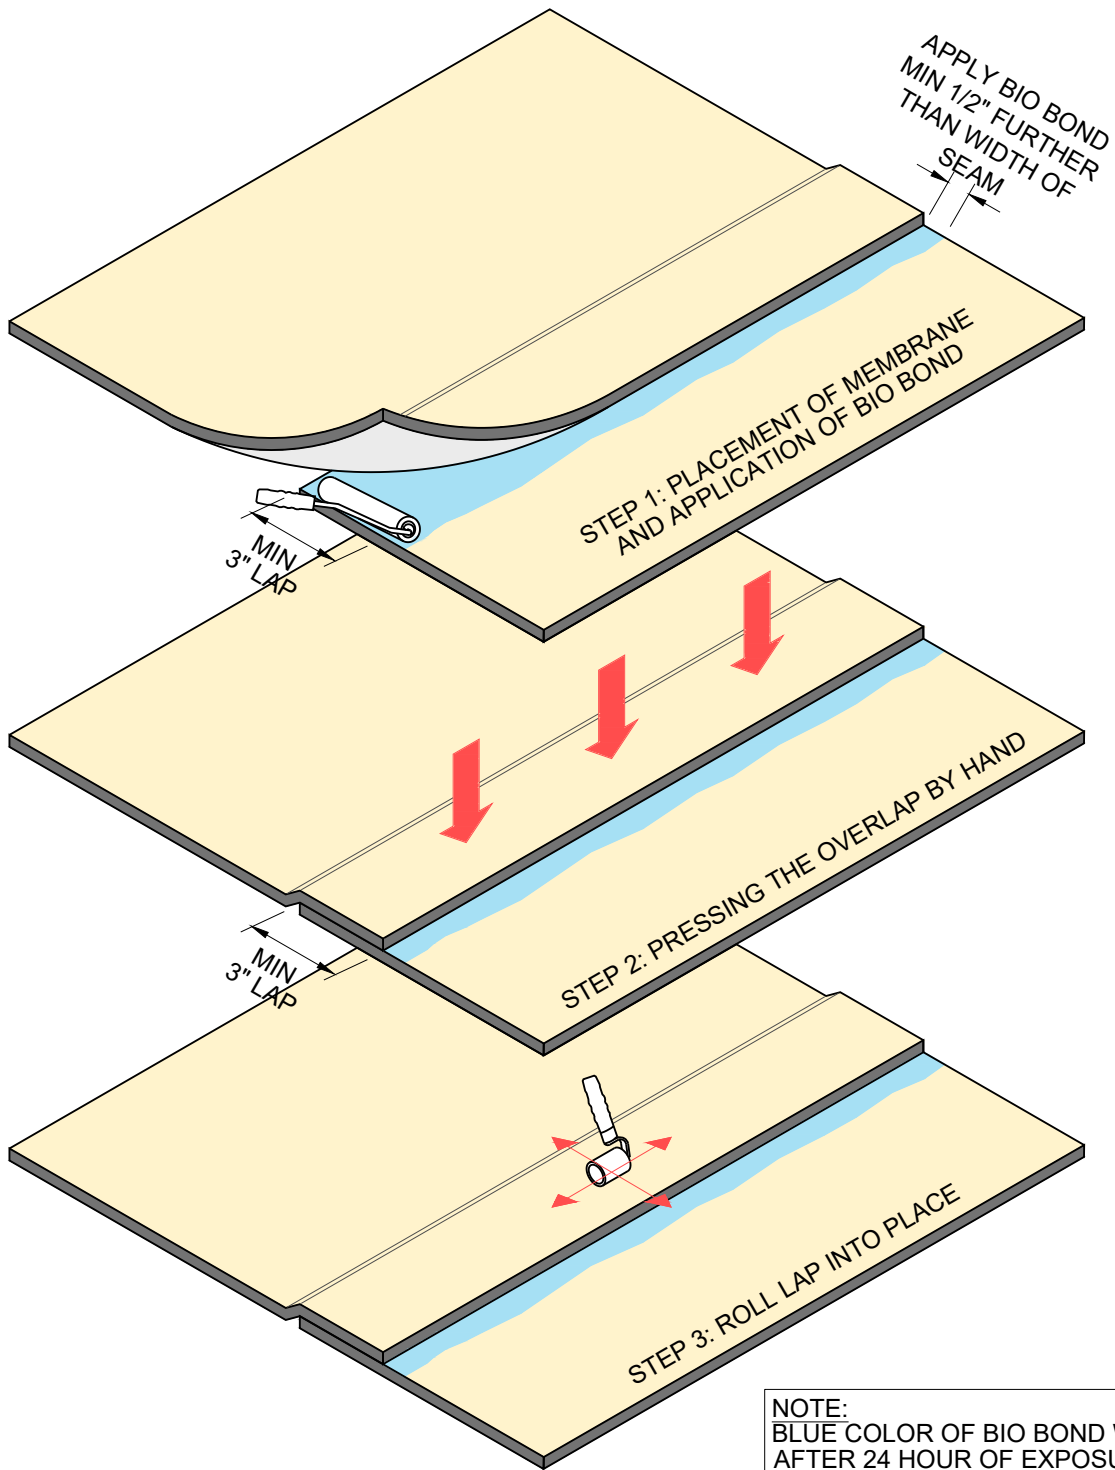
LR008

NOTE:
BLUE COLOR OF BIO BOND WILL DISAPPEAR
AFTER 24 HOUR OF EXPOSURE

TYPICAL LAP ATTACHMENT DETAIL

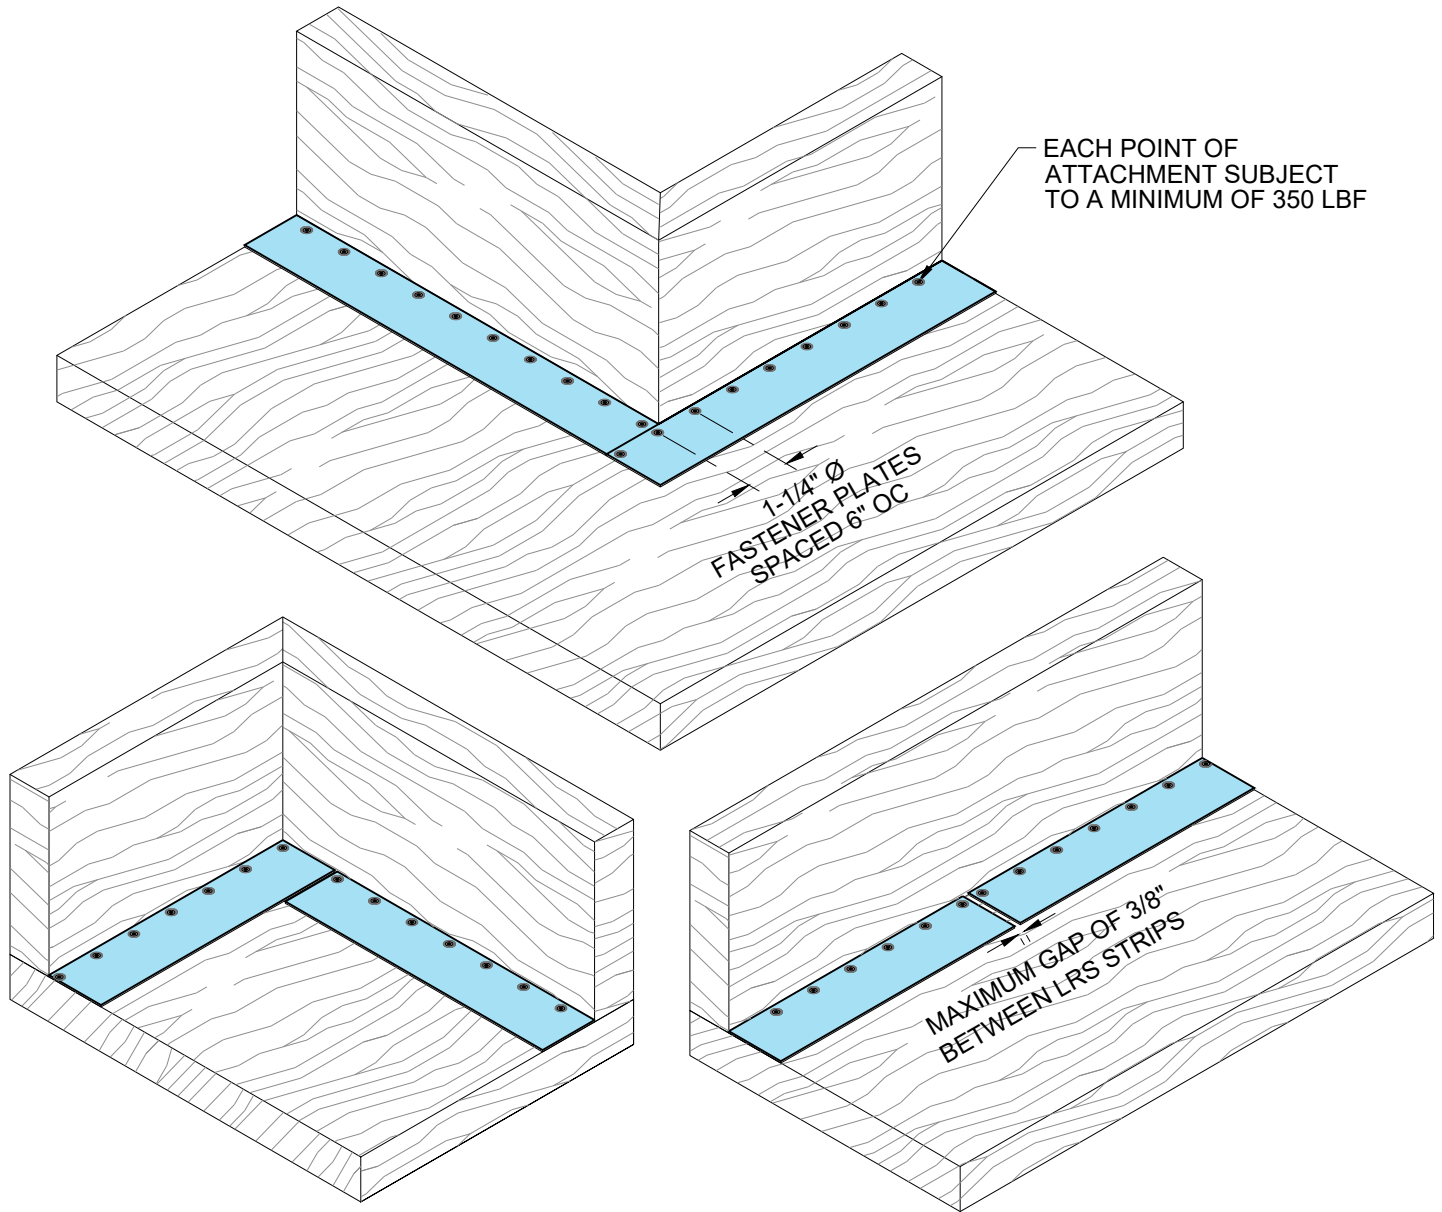
LR009

LEADAX LRS STRIPS MAY NOT OVERLAP AT
INSIDE AND OUTSIDE CORNERS

LEADAX REINFORCED STRIP (LRS) FASTENING

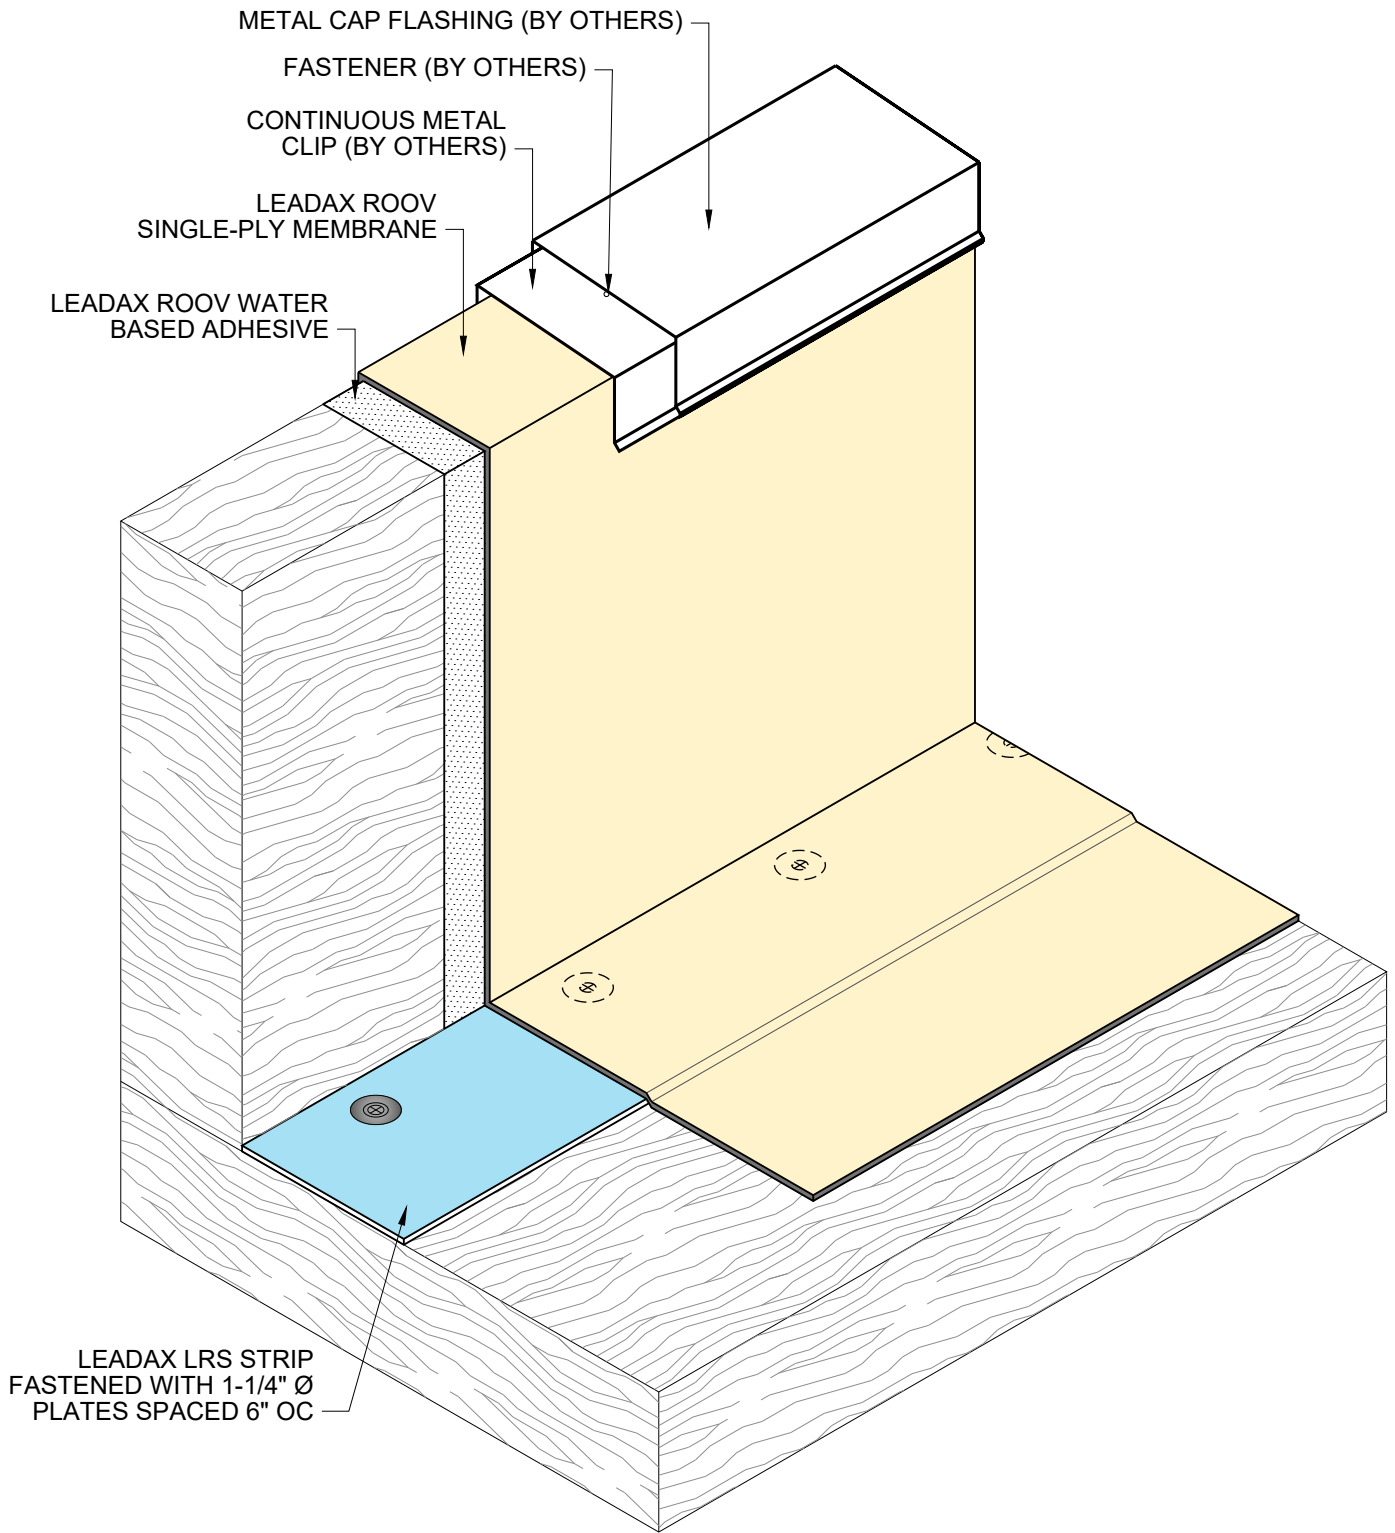
LR010

[TYPE 1 TERMINATION]
ASSEMBLY DETAIL WITH METAL COPING CAP FLASHING

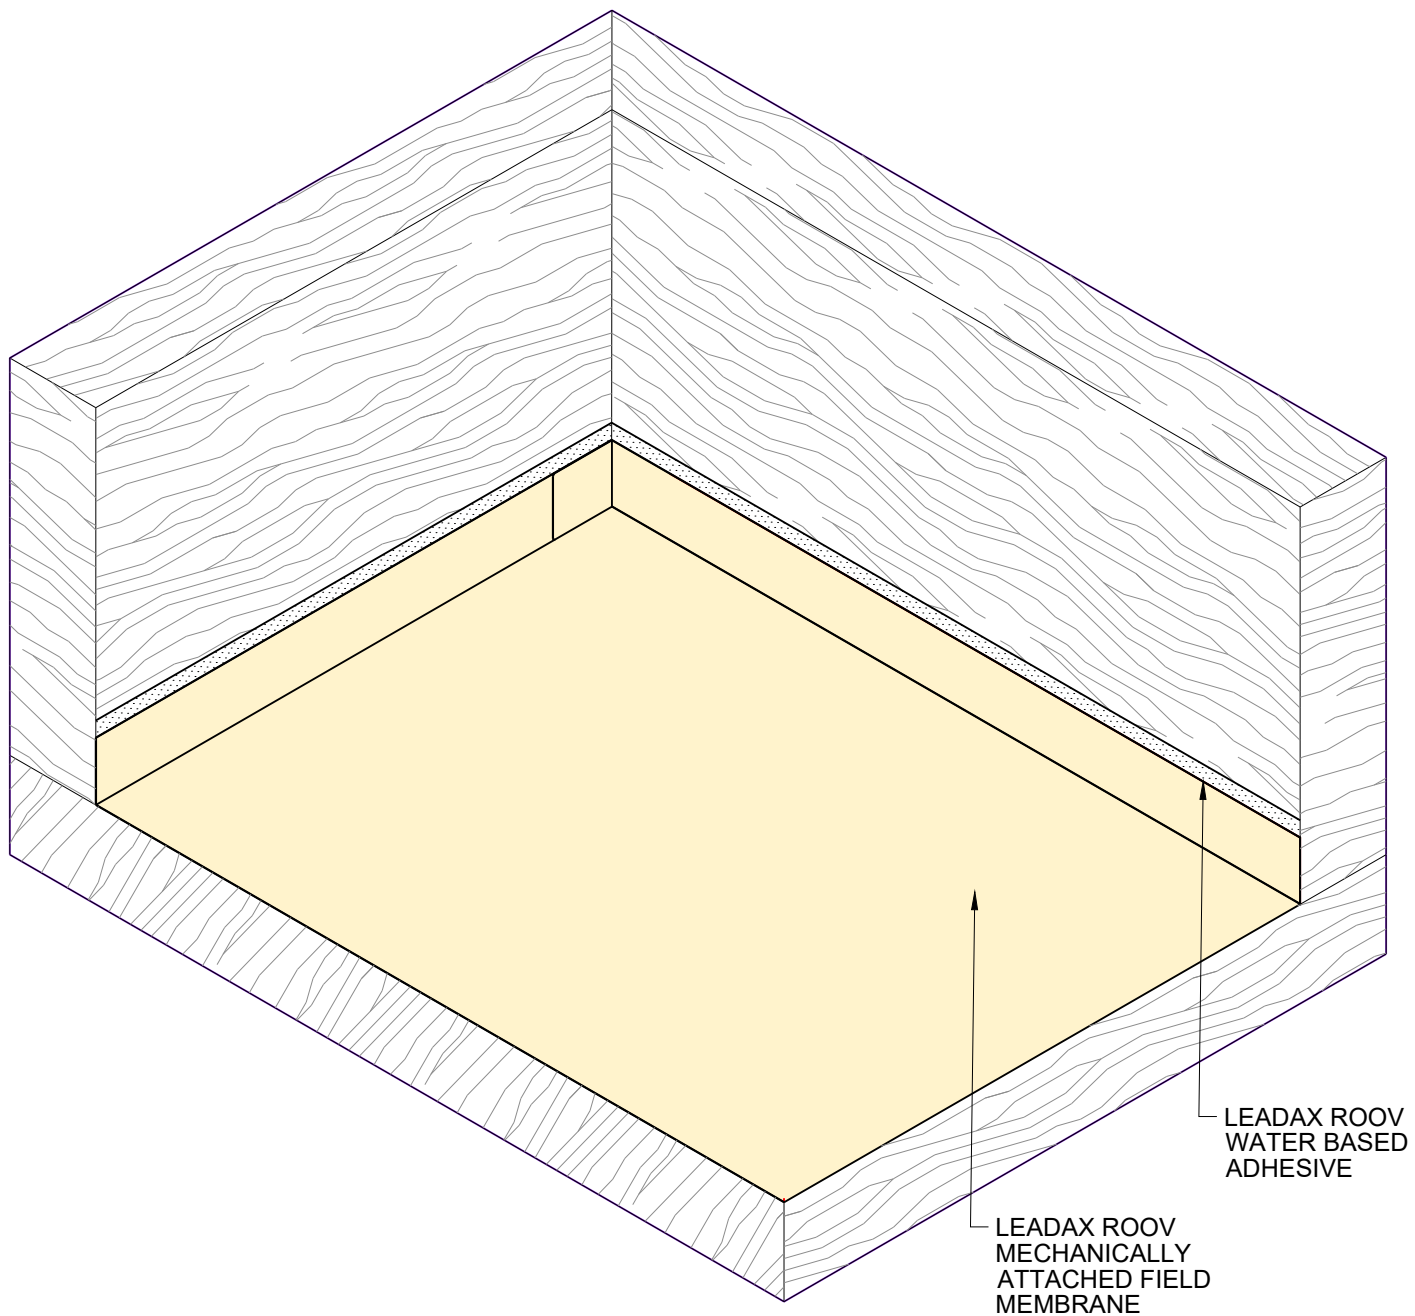
LR013

[TYPE 3 TERMINATION]
INSIDE CORNER TERMINATION - STEP 01

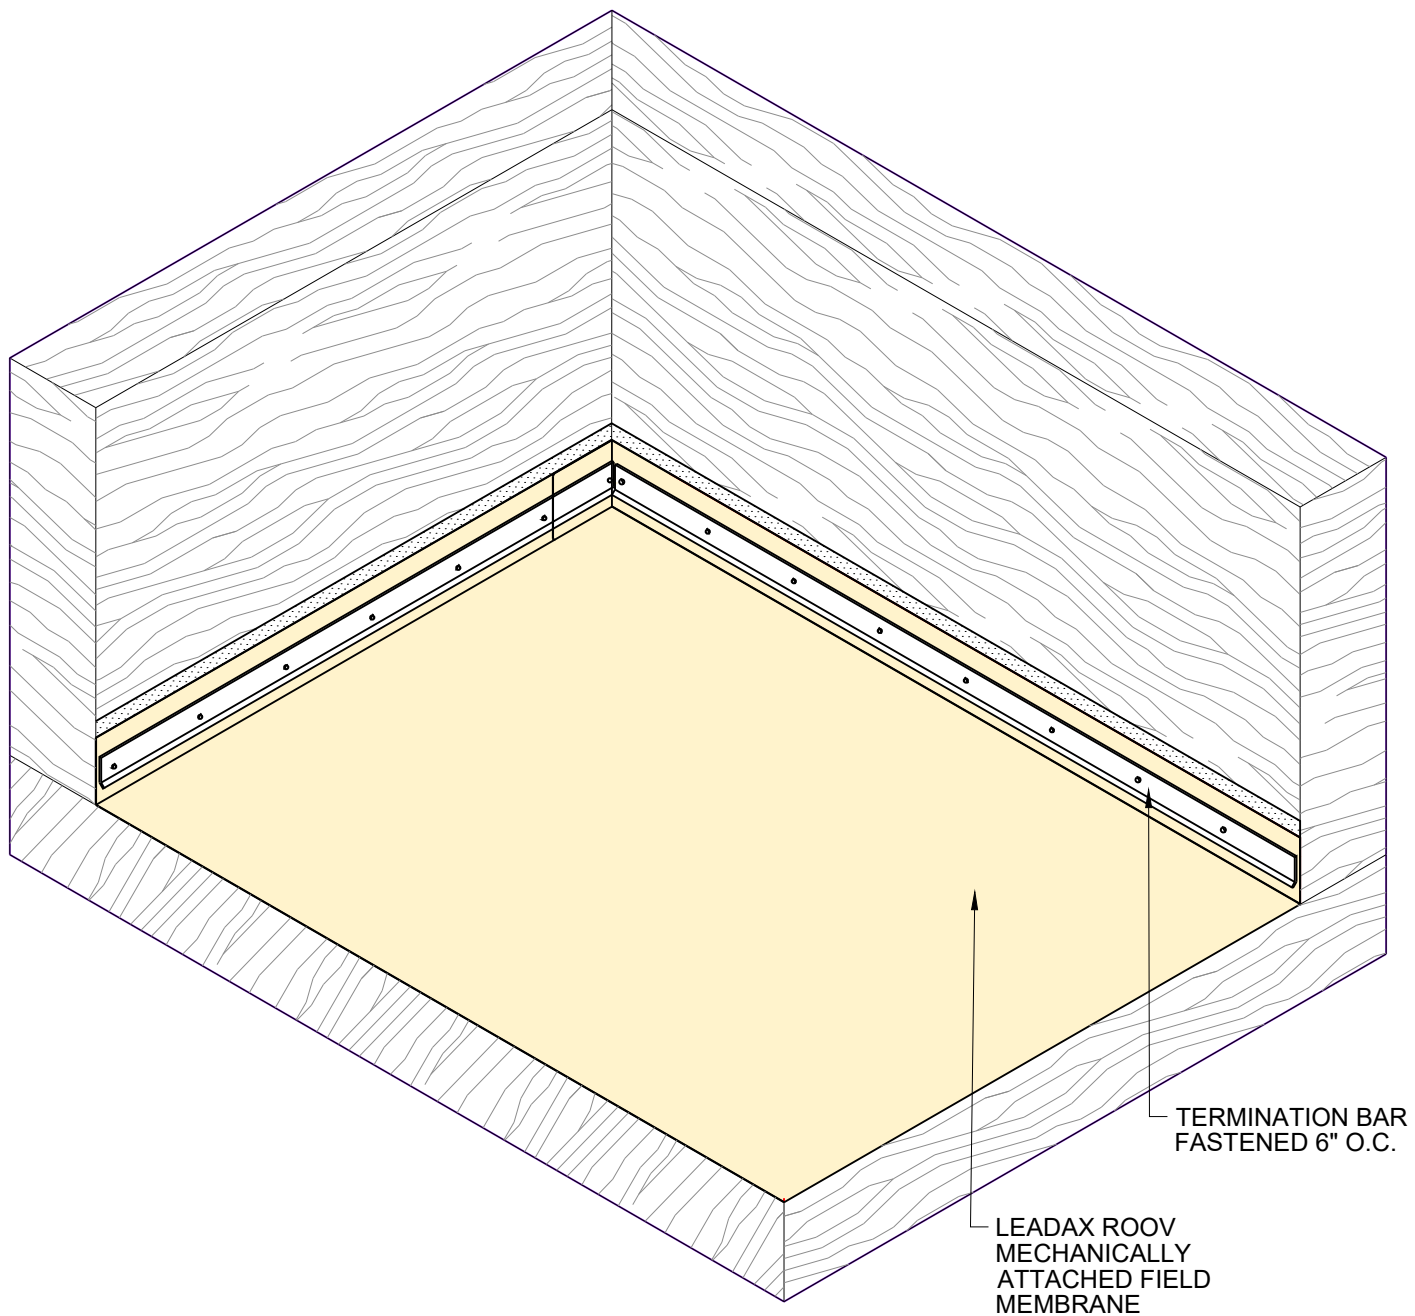
LR014

[TYPE 3 TERMINATION]
INSIDE CORNER TERMINATION - STEP 02

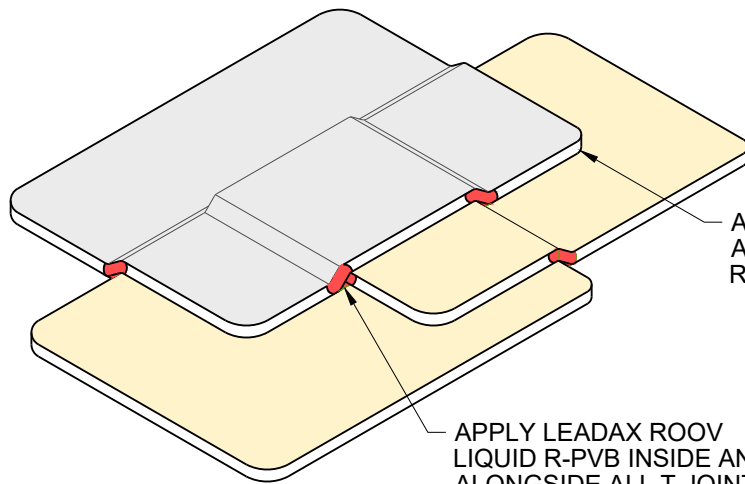
LR016

ALL FIELD CUT PATCHES
AND ROLLS SHALL HAVE
ROUNDED CORNERS

APPLY LEADAX ROOV
LIQUID R-PVB INSIDE AND
ALONGSIDE ALL T-JOINTS

TYPICAL T-LAP DETAIL

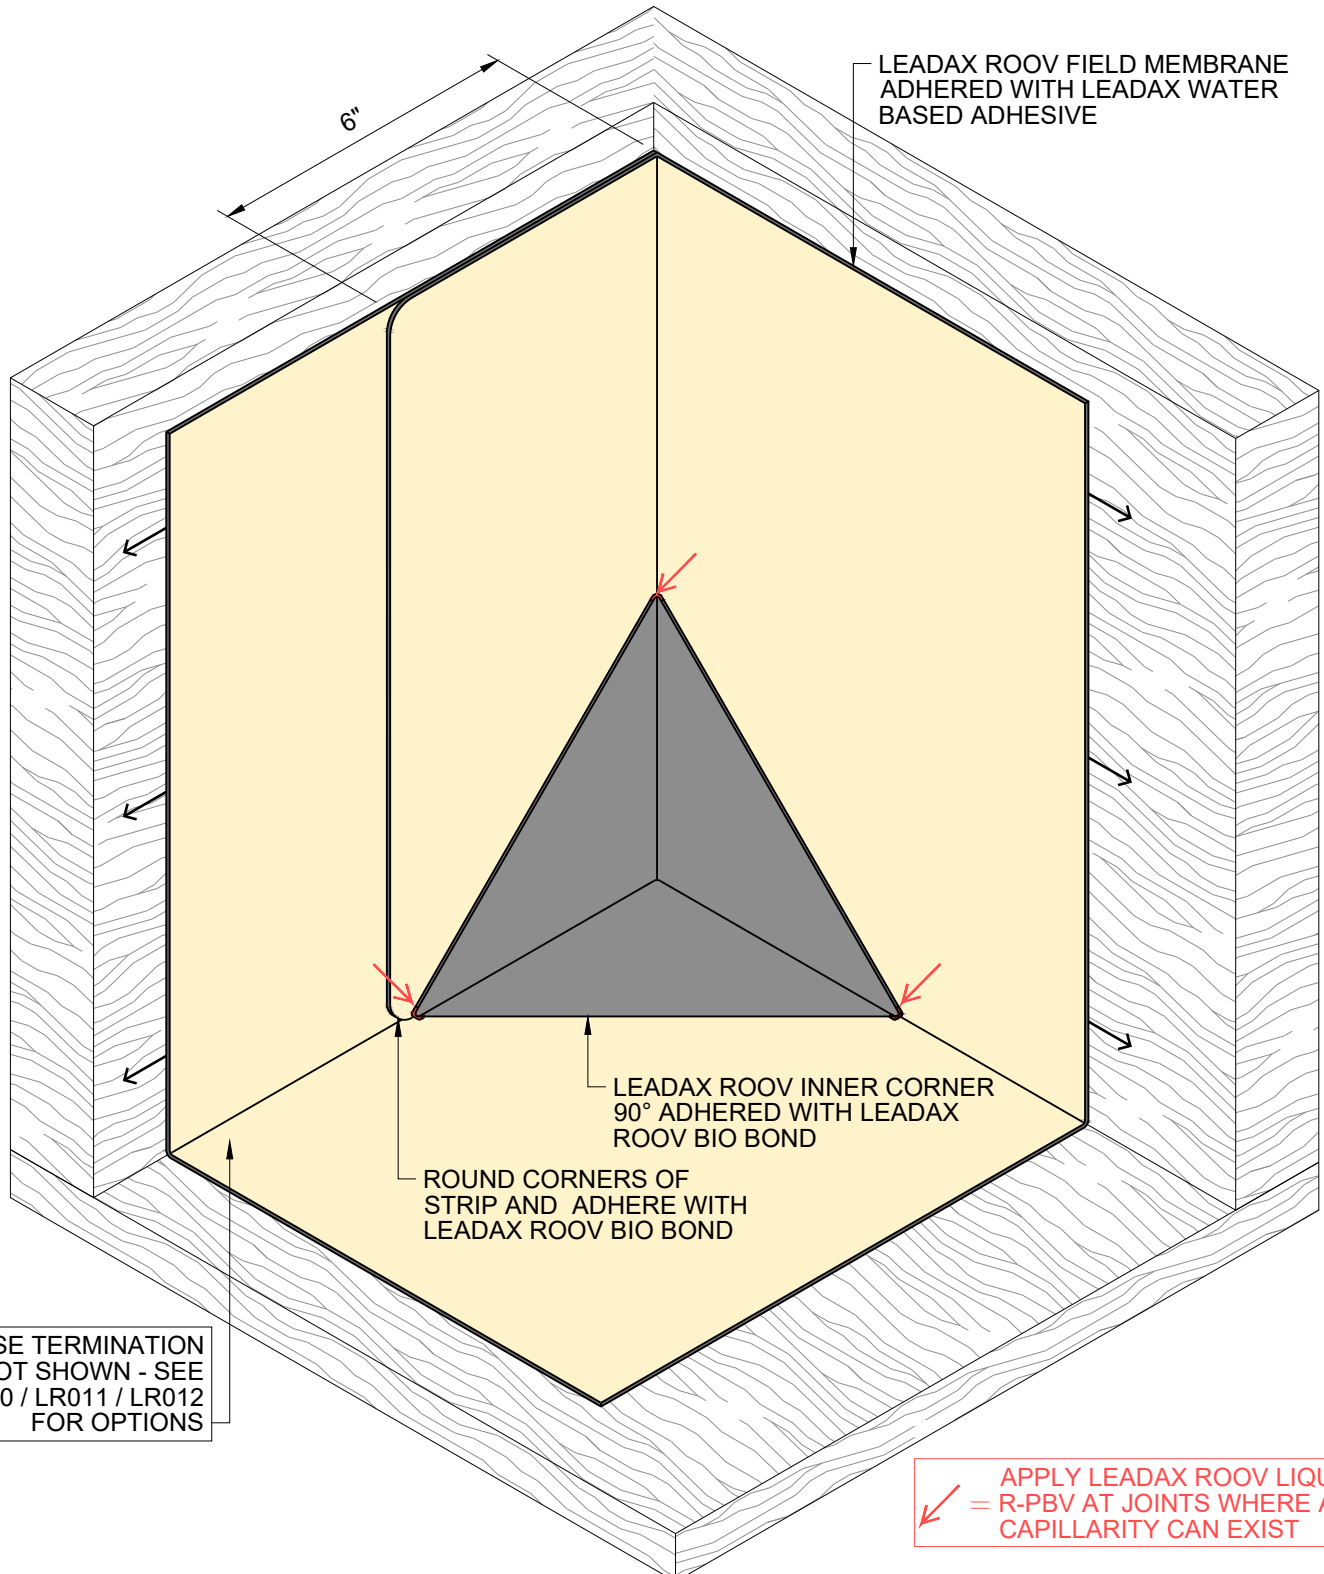
LR017

TYPICAL INSIDE CORNER FLASHING DETAIL

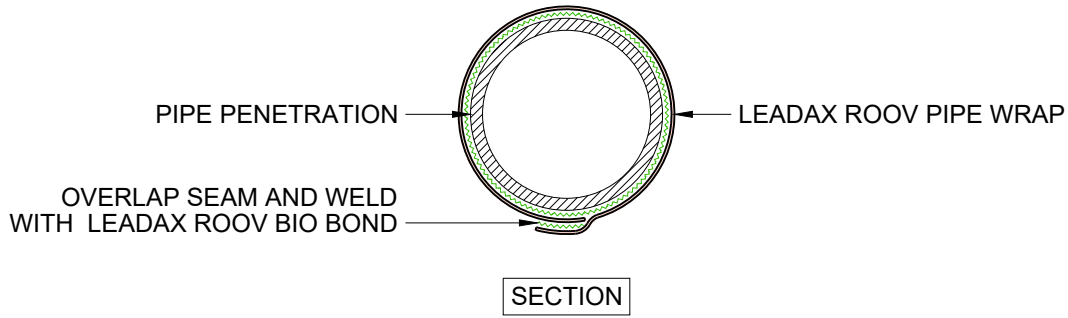
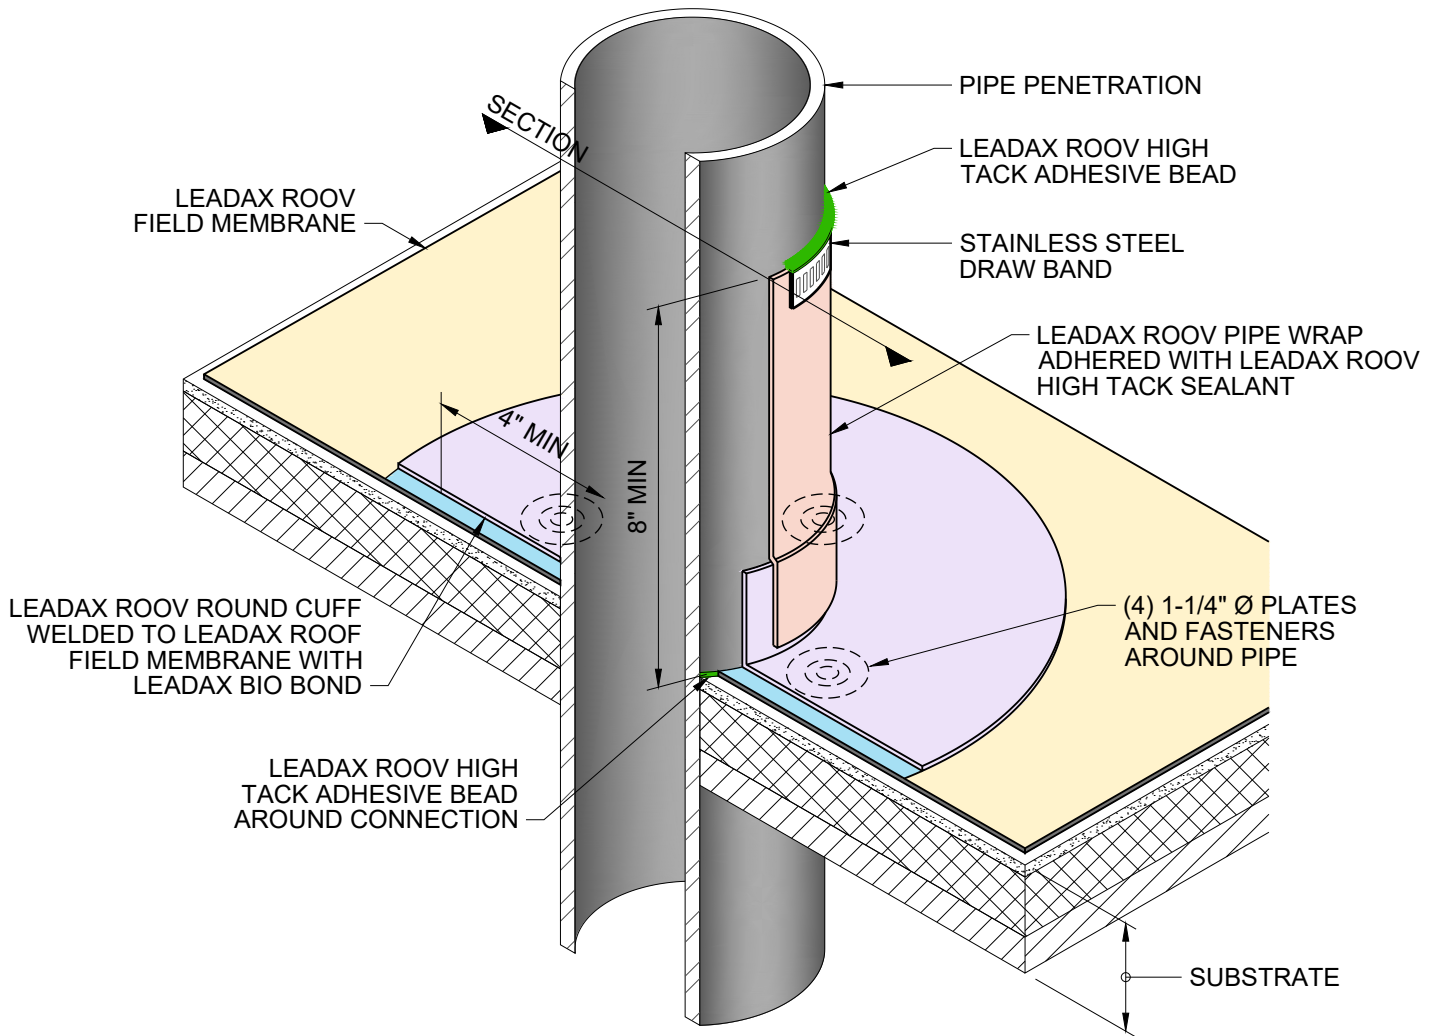
LR019

TYPICAL PIPE PENETRATION FLASHING DETAIL

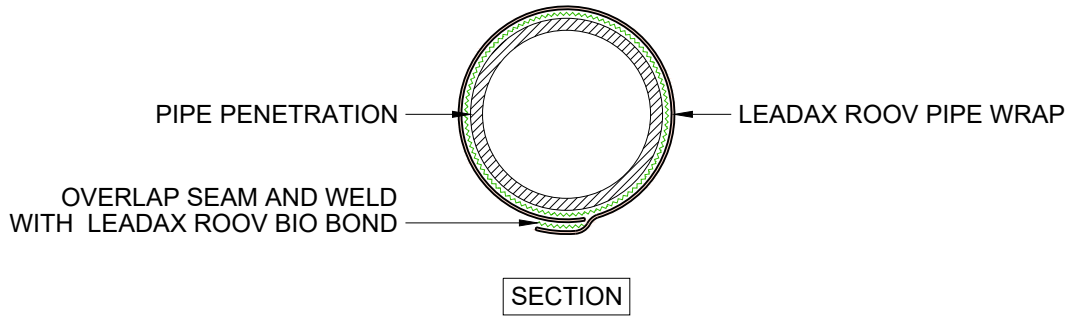
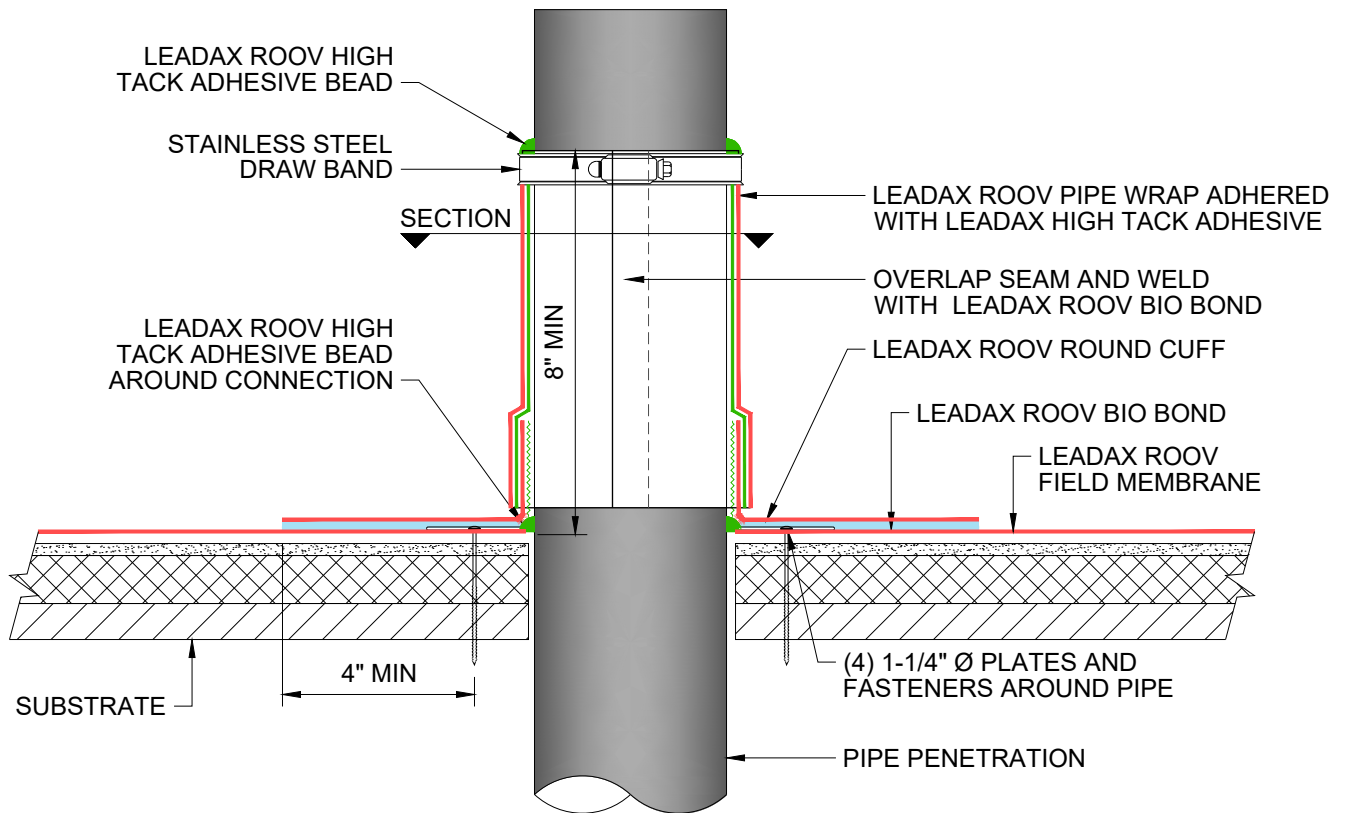
LR020

[ALTERNATE]
TYPICAL PIPE PENETRATION FLASHING DETAIL
