Ir. R.R. van der Zeelaan 10
8191 HZ Wapenveld, The Netherlands

INSTALLATION DETAILS

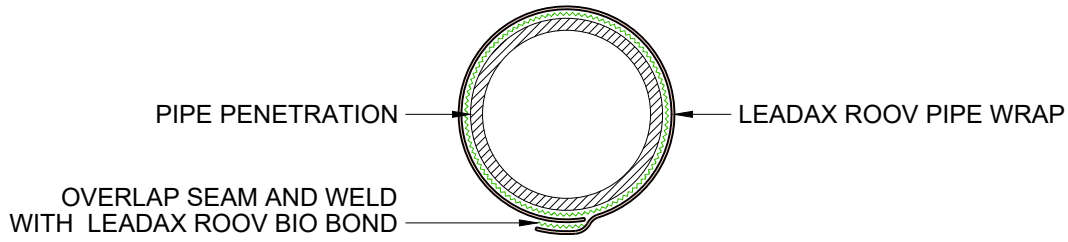
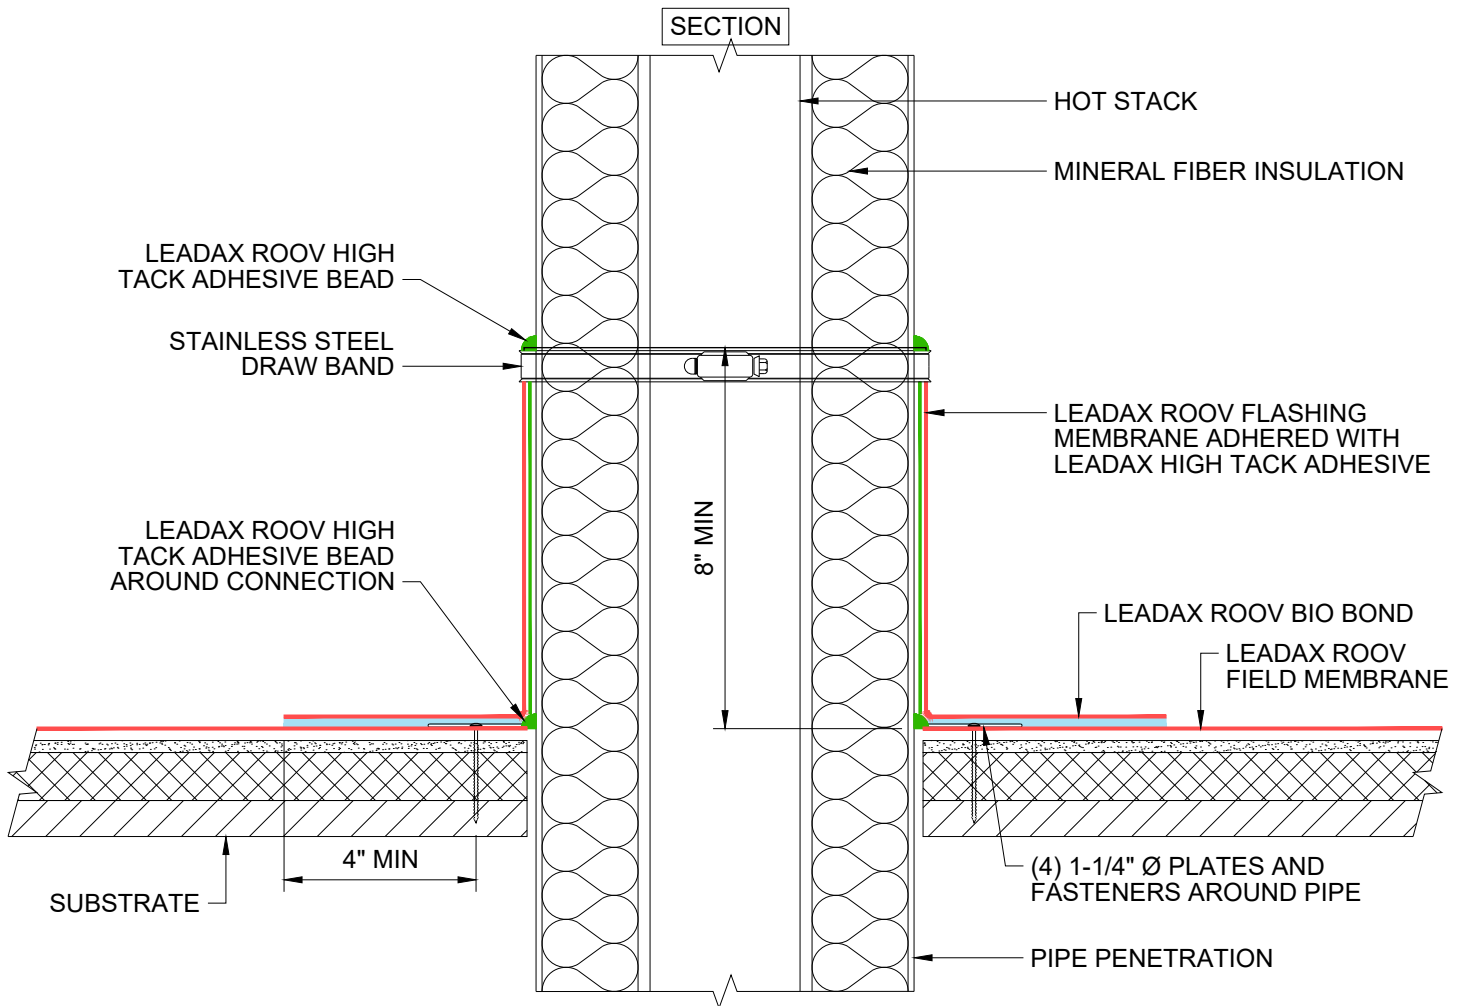
LR021

TYPICAL HOT STACK PENETRATION FLASHING DETAIL

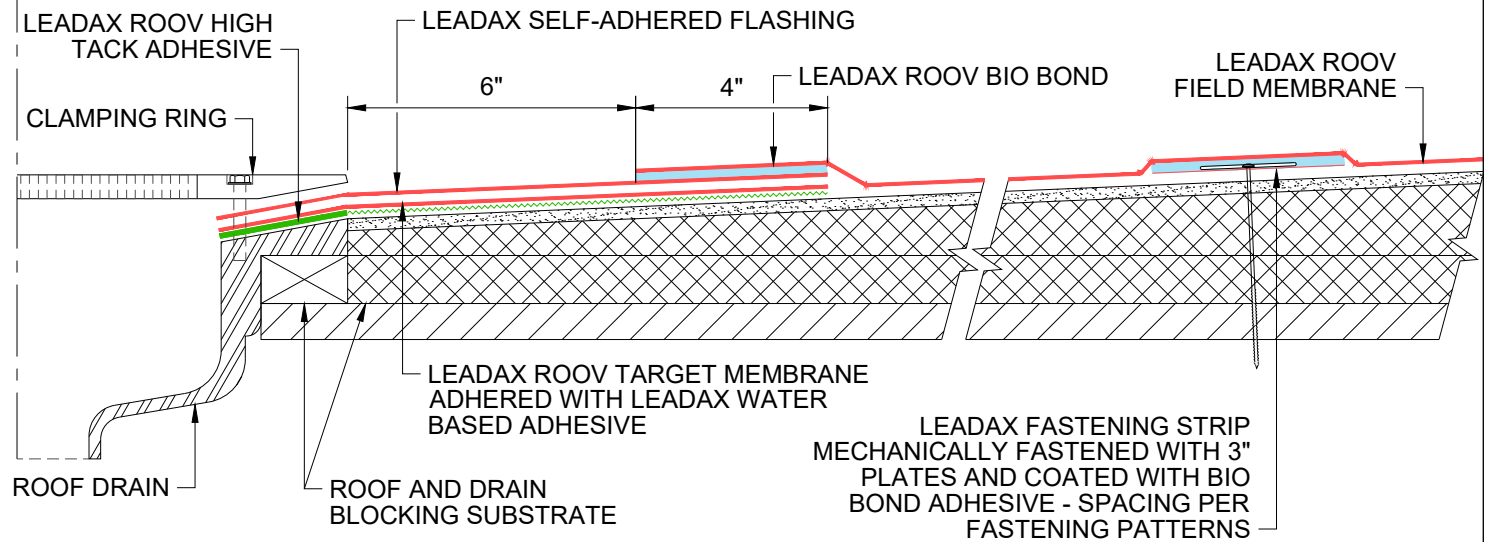
LR022

SYMMETRICAL
ABOUT CENTERLINE

TYPICAL DRAIN FLASHING DETAIL

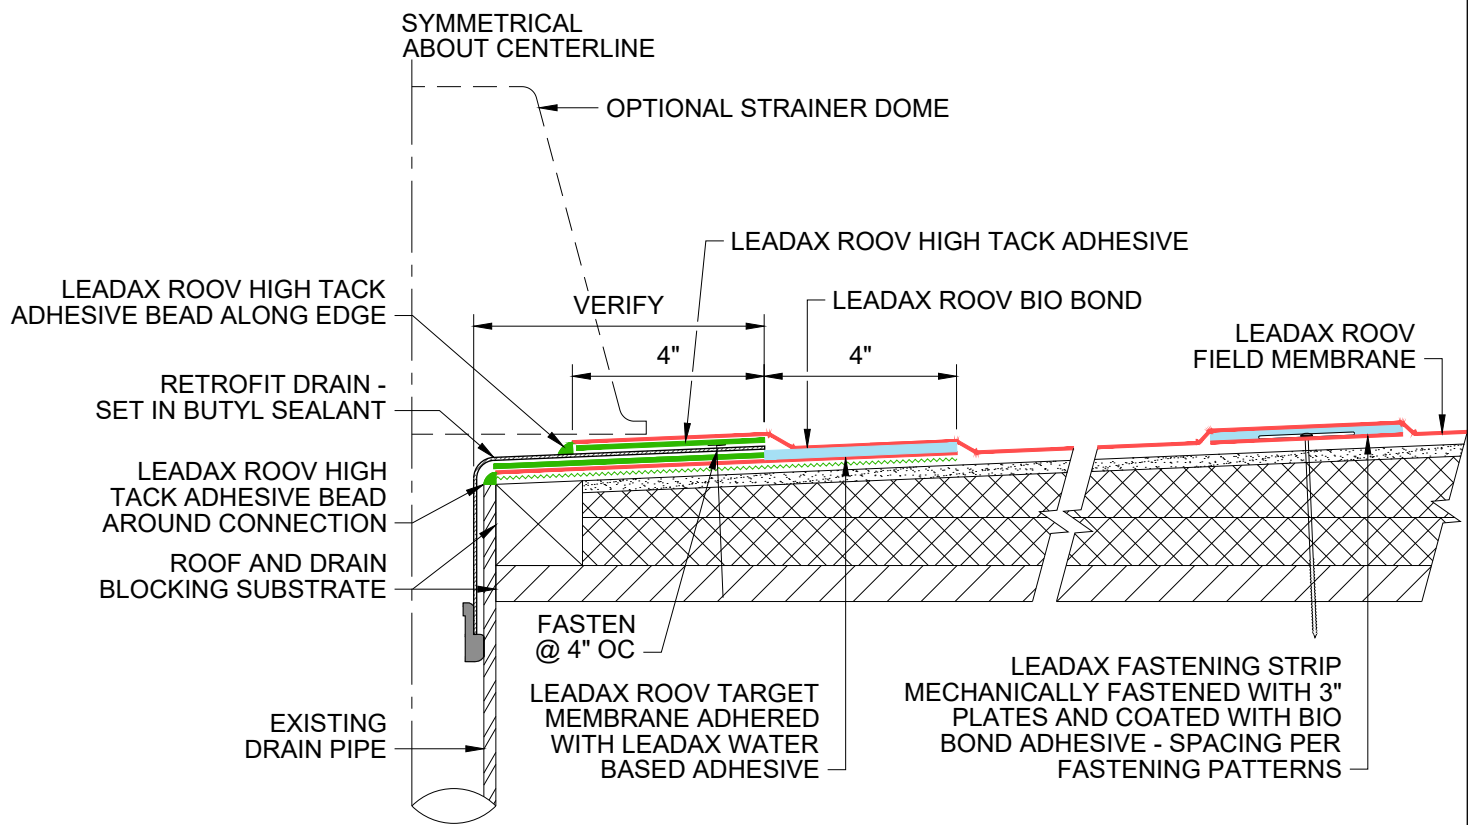
LR023

TYPICAL RETROFIT DRAIN INSERT FLASHING DETAIL

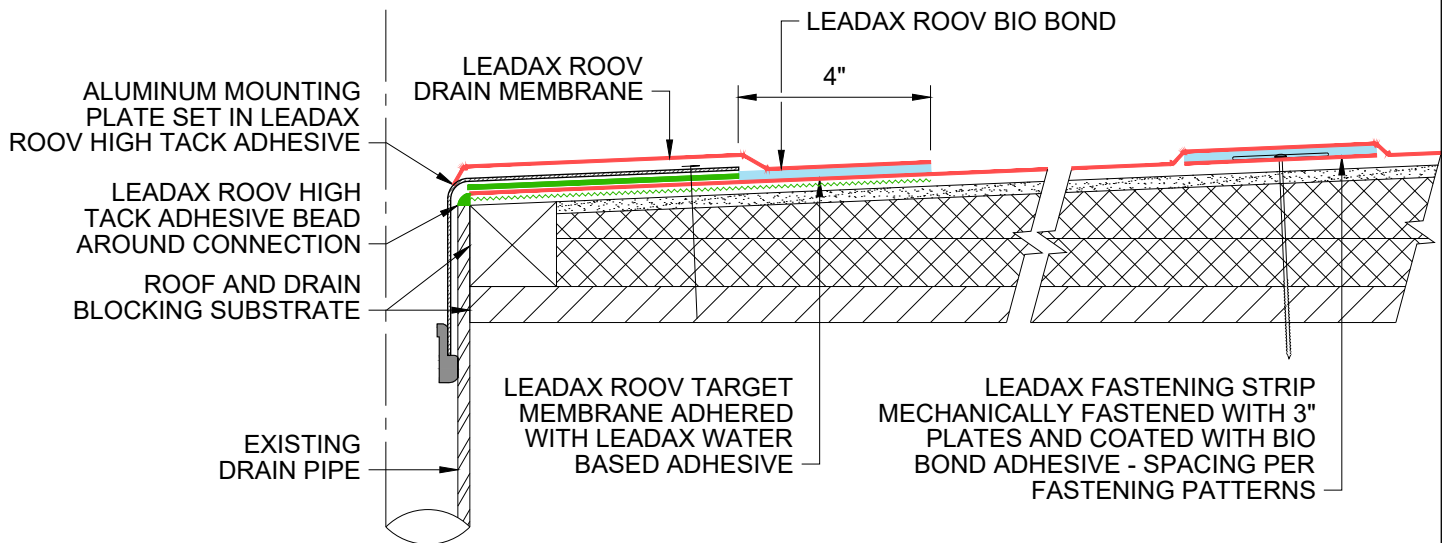
LR024

SYMMETRICAL
ABOUT CENTERLINE

LEADAX DRAIN INSERT FLASHING DETAIL

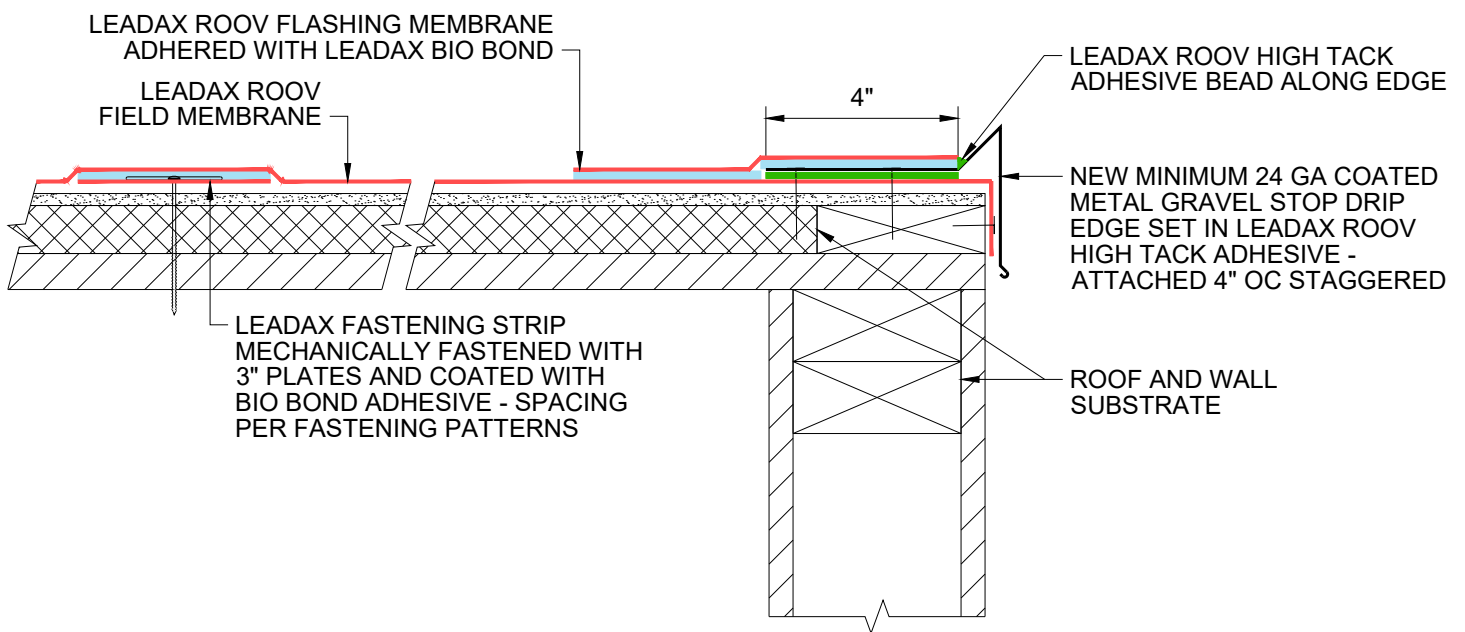
LR026

TYPICAL ROOF EDGE GRAVEL STOP FLASHING DETAIL

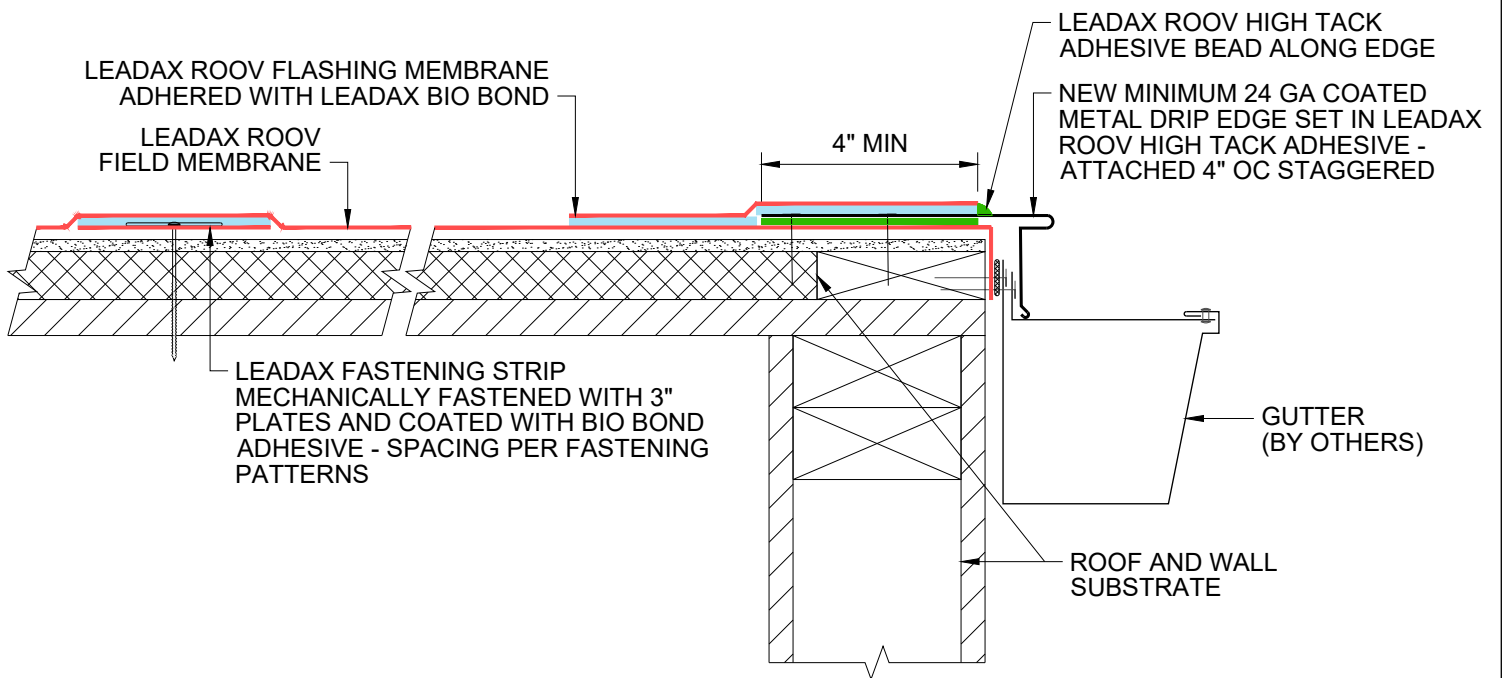
LR027

TYPICAL ROOF EDGE GUTTER FLASHING DETAIL

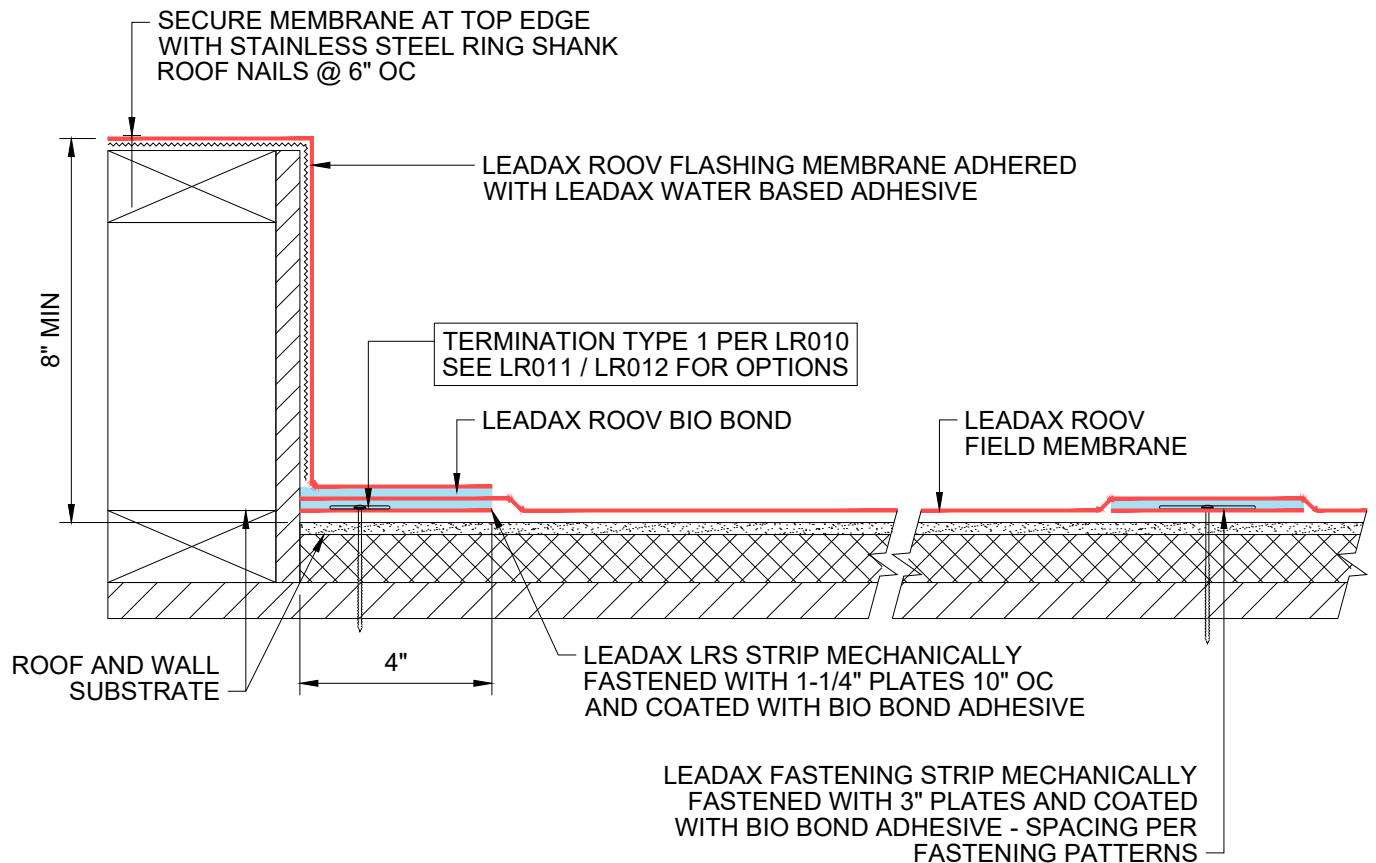
LR028

NOTE:
WHERE WALLS HAVE TRACES OF ASPHALT,
INSTALL SEPARATION LAYER OF CEMENT
BOARD OR PLYWOOD AS NEW SUBSTRATE

TYPICAL BASE FLASHING DETAIL

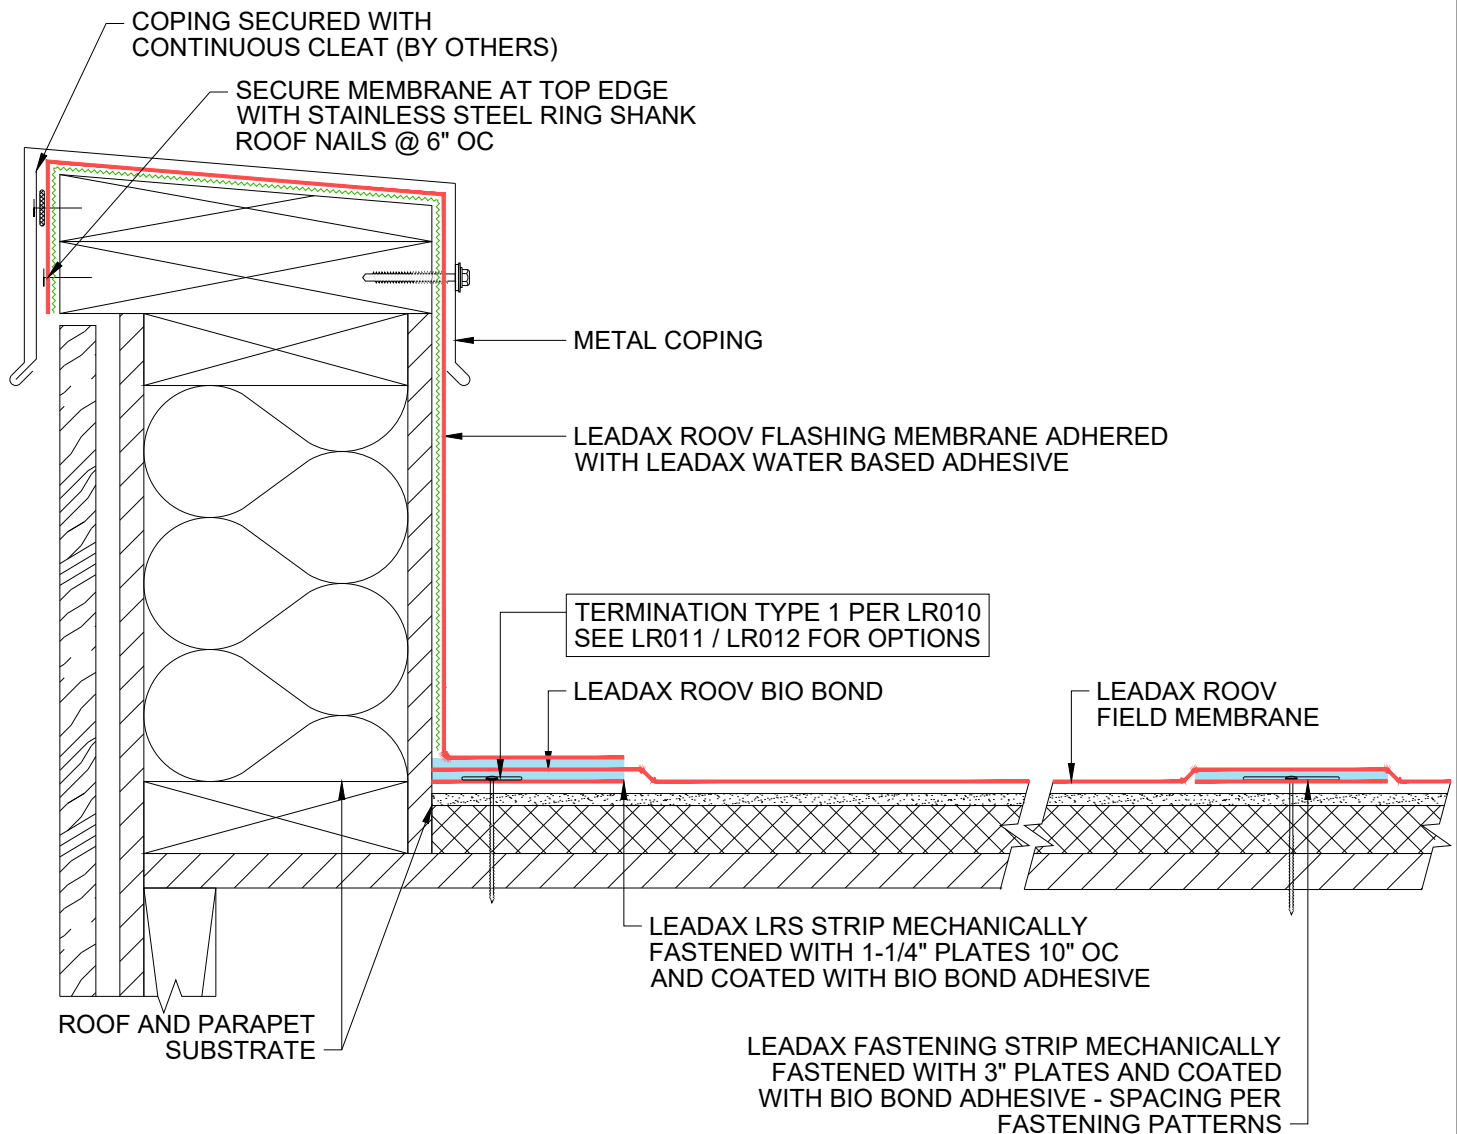
NOTE:
WHERE WALLS HAVE TRACES OF ASPHALT,
INSTALL SEPARATION LAYER OF CEMENT
BOARD OR PLYWOOD AS NEW SUBSTRATE

TYPICAL COPING FLASHING DETAIL

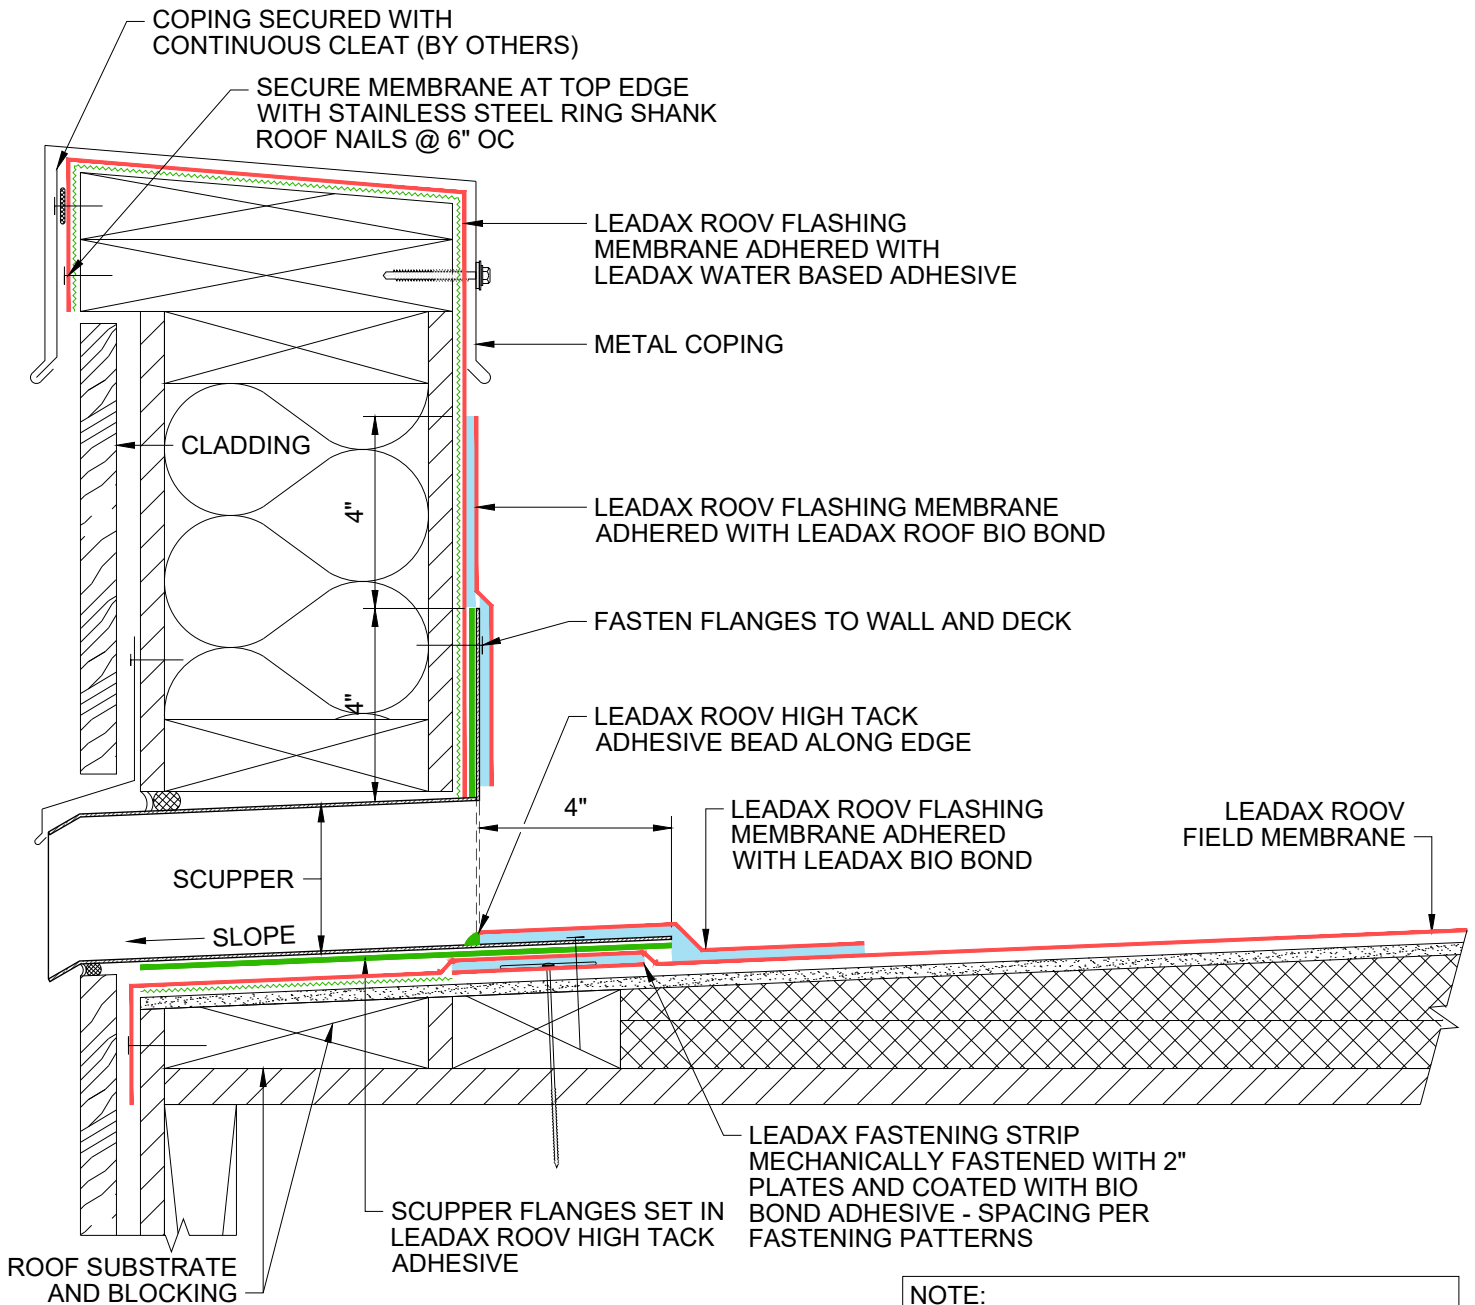
NOTE:
WHERE WALLS HAVE TRACES OF ASPHALT,
INSTALL SEPARATION LAYER OF CEMENT
BOARD OR PLYWOOD AS NEW SUBSTRATE

TYPICAL SCUPPER FLASHING DETAIL
